Heavy Equipment

Job # NA 1814 0184

1M1AM07Y1DM013792

Mack

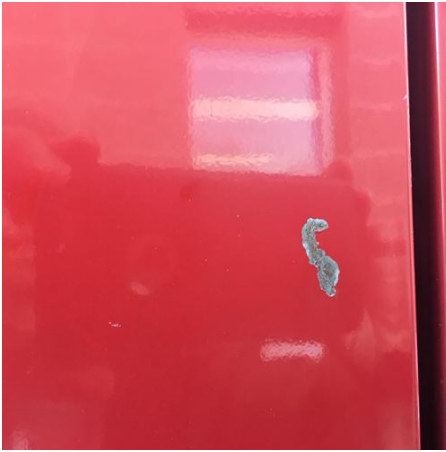
Chip
